NAVAL POSTGRADUATE SCHOOL

THESIS

**MICROSTRUCTURE AND MECHANICAL
PROPERTIES OF HIGH COPPERED HSLA-100 STEEL
IN 2-INCH PLATE FORM**

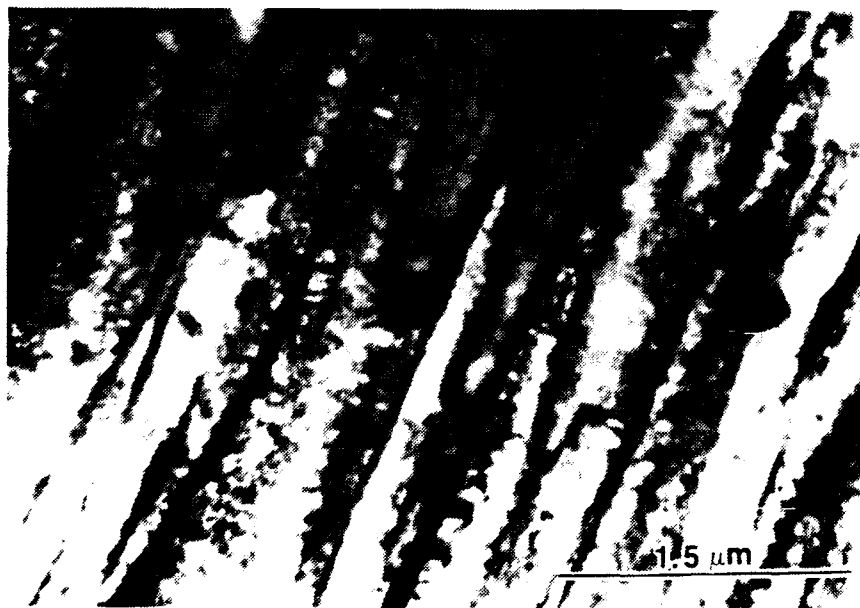
Figure 15. TEM Image Showing Lath Martensite and Retained Austenite at Lath Boundaries

The general microstructure of lath martensite/bainite, obtained from the TEM micrographs are represented in Figures 14 and 15. These show the packet boundary, which consists of bainitic ferrite, martensite and retained austenite. Autotempered carbides (Fe_3C) and the high dislocation density in the bainite lath are shown in Figure 16. Retained austenite and bainite are presented in Figure 17. Autotempered carbide precipitates were observed and presented in Figures 18 and 19. An analysis of the observations show that the strength of the as-quenched HSLA-100 steel consists of the fine transformation product packet size, high dislocation density and small lath width. The fine transformation product packet size and high dislocation density results in greater strength while the fine martensitic laths contribute to toughness.
